HISTORIC PRESERVATION RESTRICTION
between
AMERICAN YOUTH HOSTELS, INC.
and
THE TOWN OF NANTUCKET, MASSACHUSETTS

(a) the former Surfside Life Saving Station, now known as the Star of the Sea Youth Hostel (hereinafter "the Main Building"), which contains a Victorian Gothic Style two-story wood-frame structure built in 1874 and flanking Shingle Style shed additions built in 1884;

EXHIBIT B
"Building Location Plan of Land in Nantucket,
Massachusetts at 31 Western Avenue", Blackwell &
Associates, September 1, 1998
 [scale reduced]

EXHIBIT D
Massachusetts Historical Commission Survey Form B
31 Western Avenue, Nantucket – Main Building
Page 5 of 5

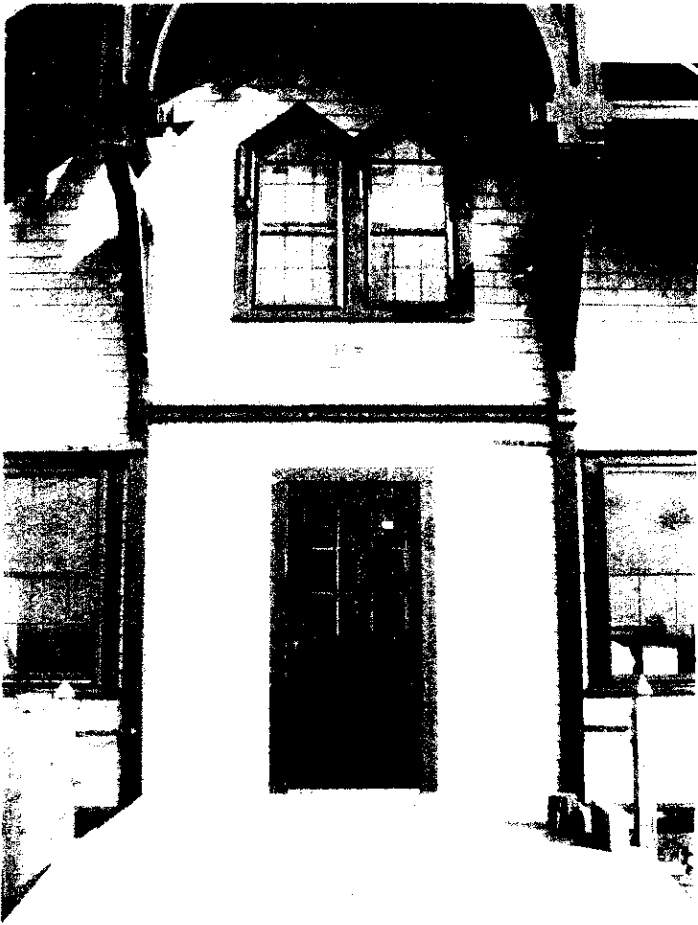
Photo #2 of 17 façade main entry & ramp

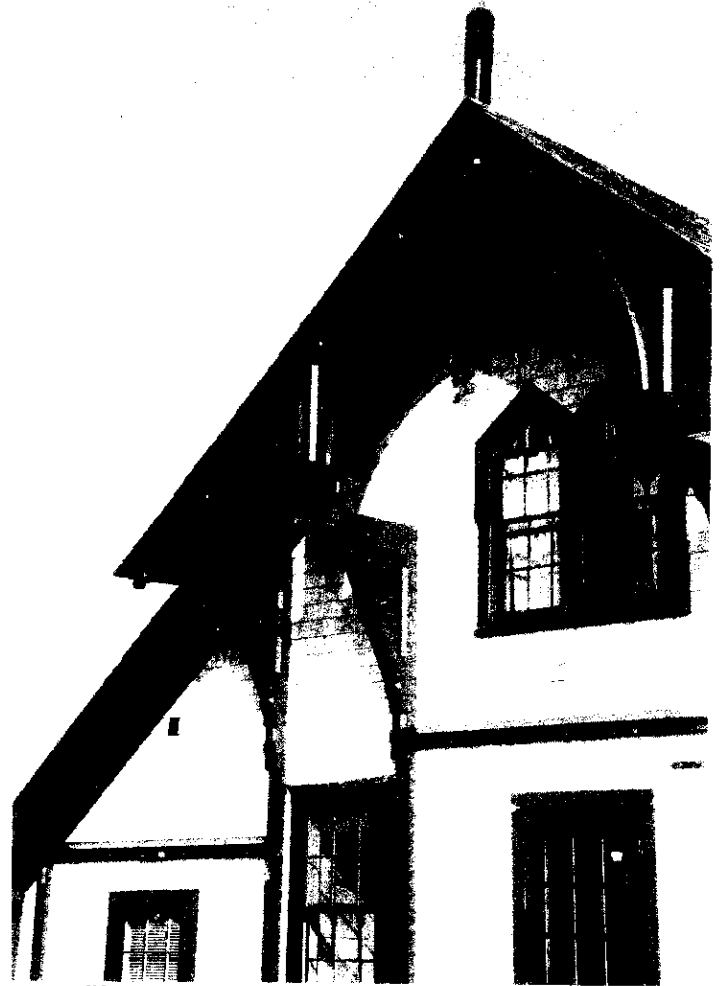
Photo #3 of 17 façade detail of decorative truss

Façade (south elevation) detail of decorative
hammerbeam truss at gable

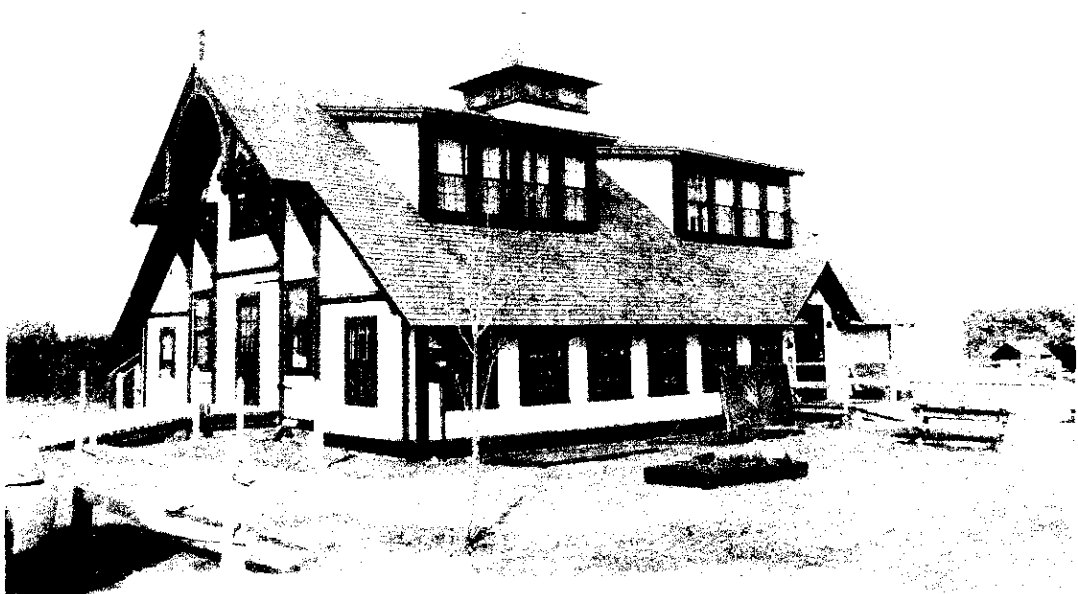
Photo #4 of 17 façade (south) & east elevations of station

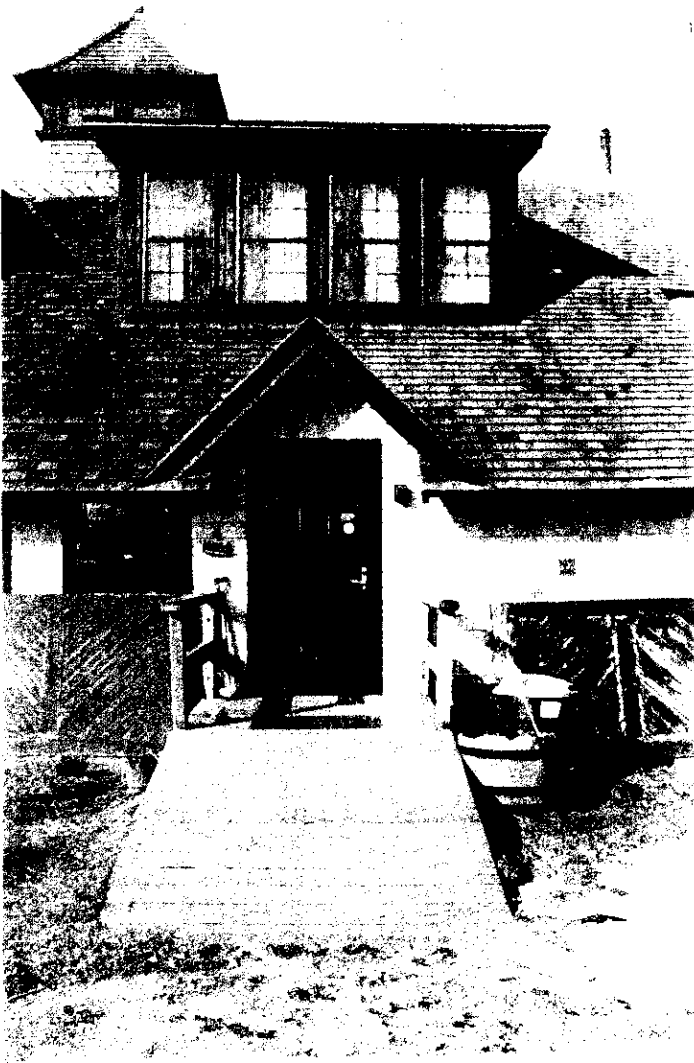
Photo #5 of 17 east elevation entry ramp & dormer

The east elevation is asymmetrically arranged with six evenly spaced 6/6 windows set south of a gabled entry at the first storey. Set in flat-stock frames, these windows were probably added in 1919. The gabled entry consists of a contemporary wooden door composed of four panels surmounted by a four-pane light. The door is partially sheltered from the weather by a shallow gable. This doorway was originally protected by a small porch which was removed after 1978 and replaced by the present gable and door. Wall surfaces north of the doorway are blank. An open eave with decorated rafter tails extends across the east elevation at the head of the first storey. The second storey contains two shed dormers added in 1919. Each dormer possesses a battery of four 6/6 windows set in flat-stock frames. At the head of each dormer, eaves are open and rafter tails are decorated to match those of the first storey.

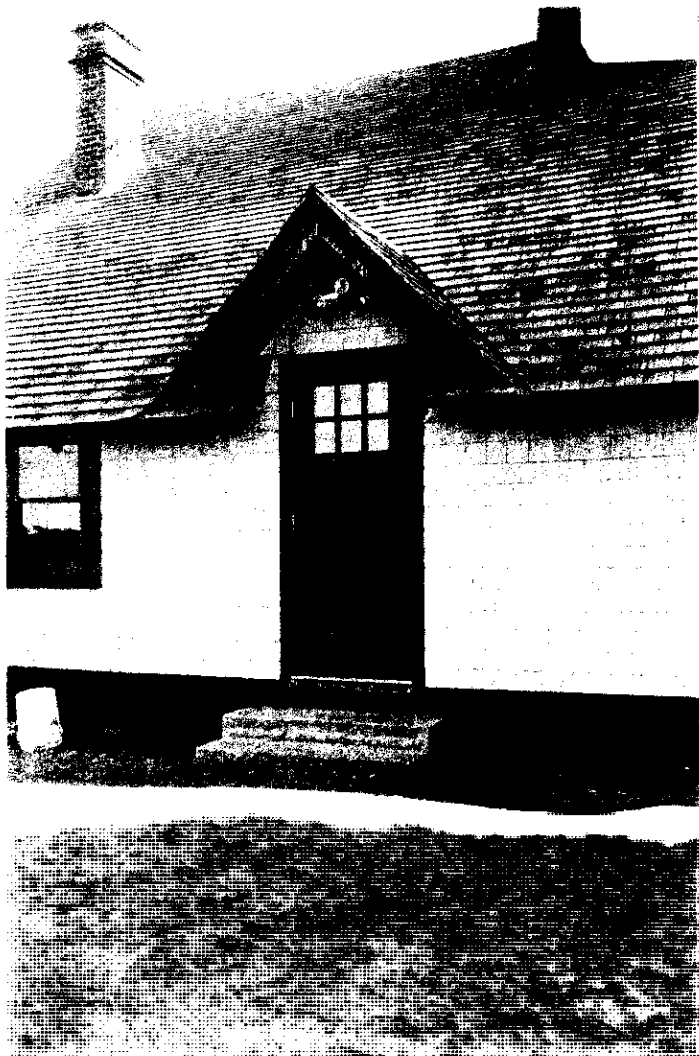
Photo #8 of 17 - west elevation - view of rear entry

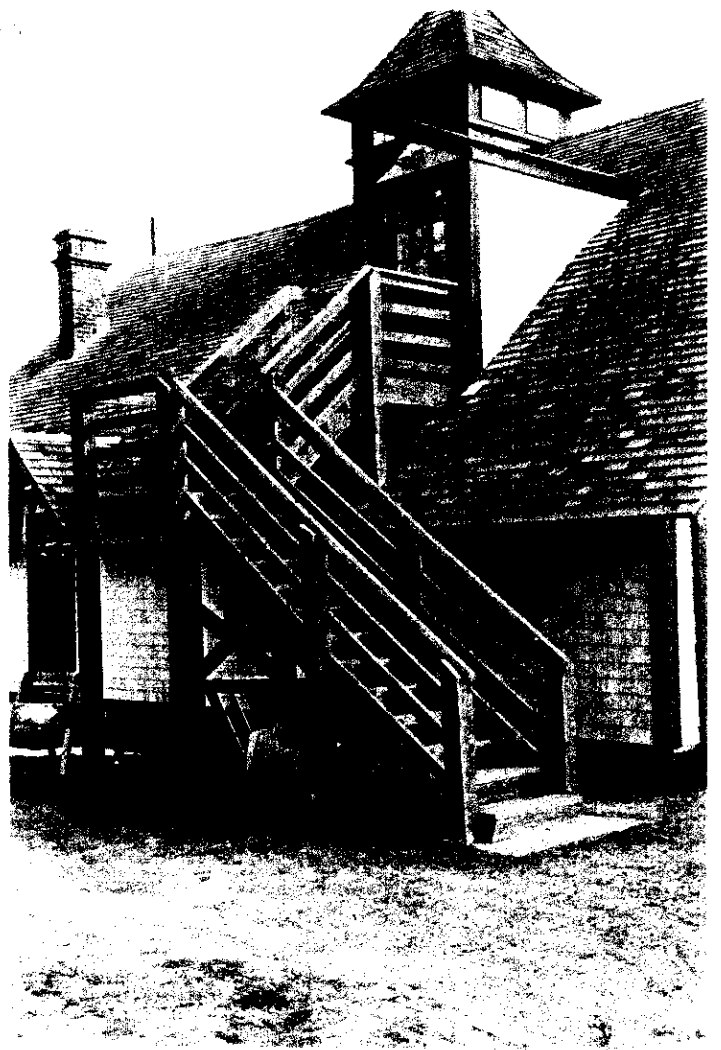
Photo #9 of 17 - west elevation - added dormer & escape

West elevation - view of added dormer & fire escape

By 1884 the original station proved too small for the necessary equipment and crew, and it was expanded by the construction of identical shed additions on the east and west elevations of the original building. Each addition provided space for equipment carts and carriages. At the same time, the open observation platform was replaced with an enclosed cupola that served as an observation deck. At the façade and north elevation, original Victorian Gothic trimmings and windows were retained, but exterior wall surfaces were re-clad with wood shingles to match the additions and cupola which were of simple Shingle Style design. The building continued in its 1884 form until 1919 when a Radio Direction Finders Station (Navy Radio Compass Station) was established on the property. To accommodate this use and a resident crew, the interior of the station was modified between 1919 and World War II to provide living quarters, offices and common rooms. Reflecting these interior modifications the east side of the building was altered by the installation of double-hung sash at the first storey and by the addition of two shed dormers to the roof.

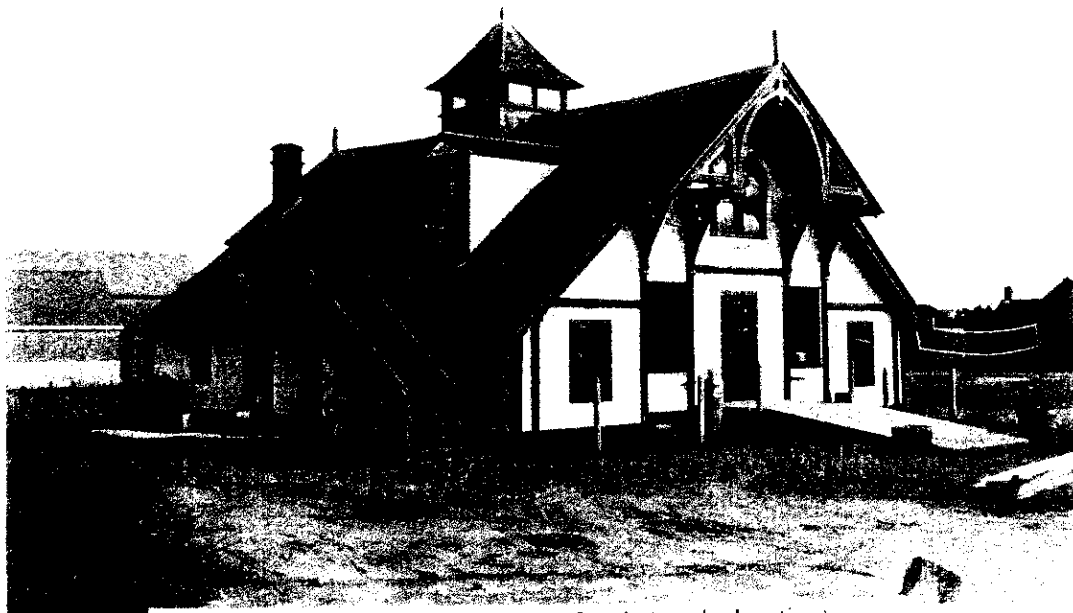
Photo #7 of 17 - west elevation & façade (south elevation)

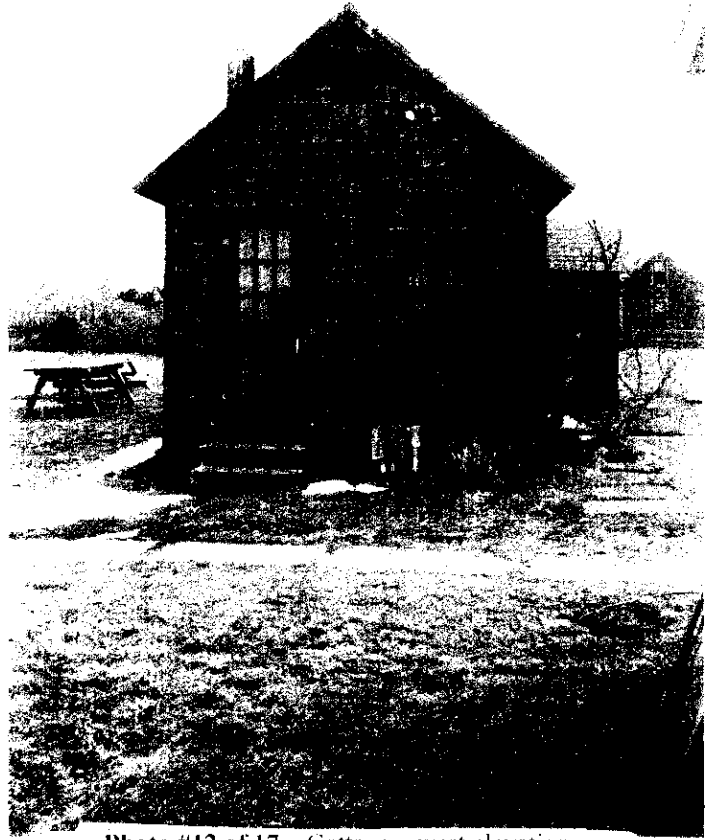
Photo #12 of 17 Cottage west elevation

MA; NANTUCKET - 31 Western Avenue - 2/24/05
Photo #12 of 17 - Surfside Life Saving Station
West elevation

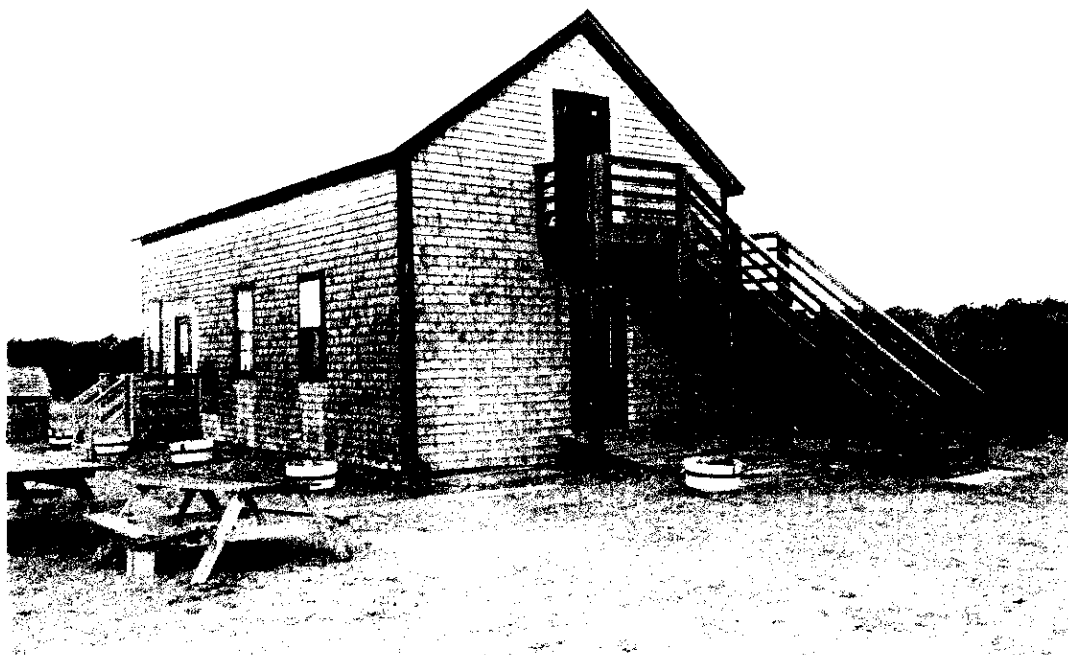
Photo #15 of 17 Stable - south & east elevations

MA: NANTUCKET - 31 Western Avenue - 2/24/05
Photo #15 of 17 - Surfside Life Saving Station Stable
South & east elevations (left to right)

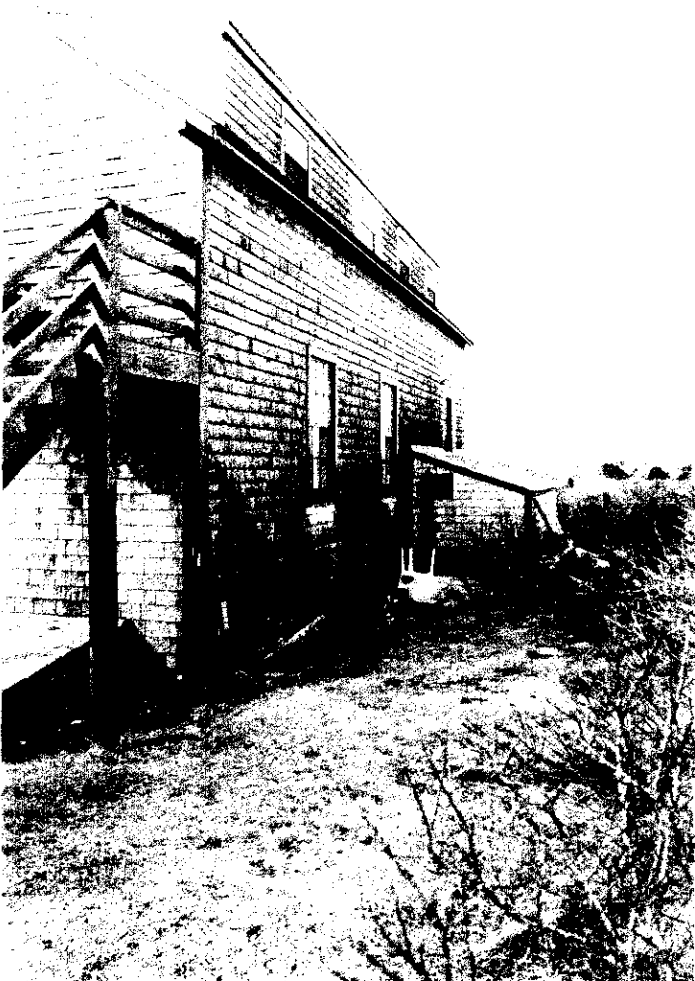
Photo #16 of 17 Stable east & north elevations (left to right)

MA: NANTUCKET - 31 Western Avenue - 2/24/05
Photo #16 of 17 - Surfside Life Saving Station Stable
Partial east elevation (left) & north elevation (right)

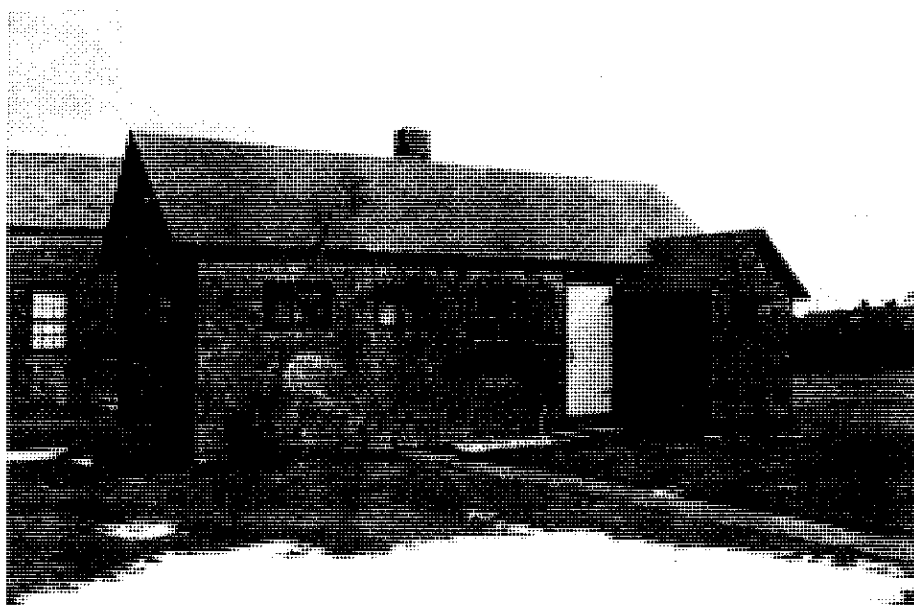
MA: NANTUCKET – 31 Western Avenue – 2/24/05
Surfside Life Saving Station Cottage – west & south
elevations (left to right)
